Ballast Holding Plate

Countermeasure to cope
with overhanging of rail

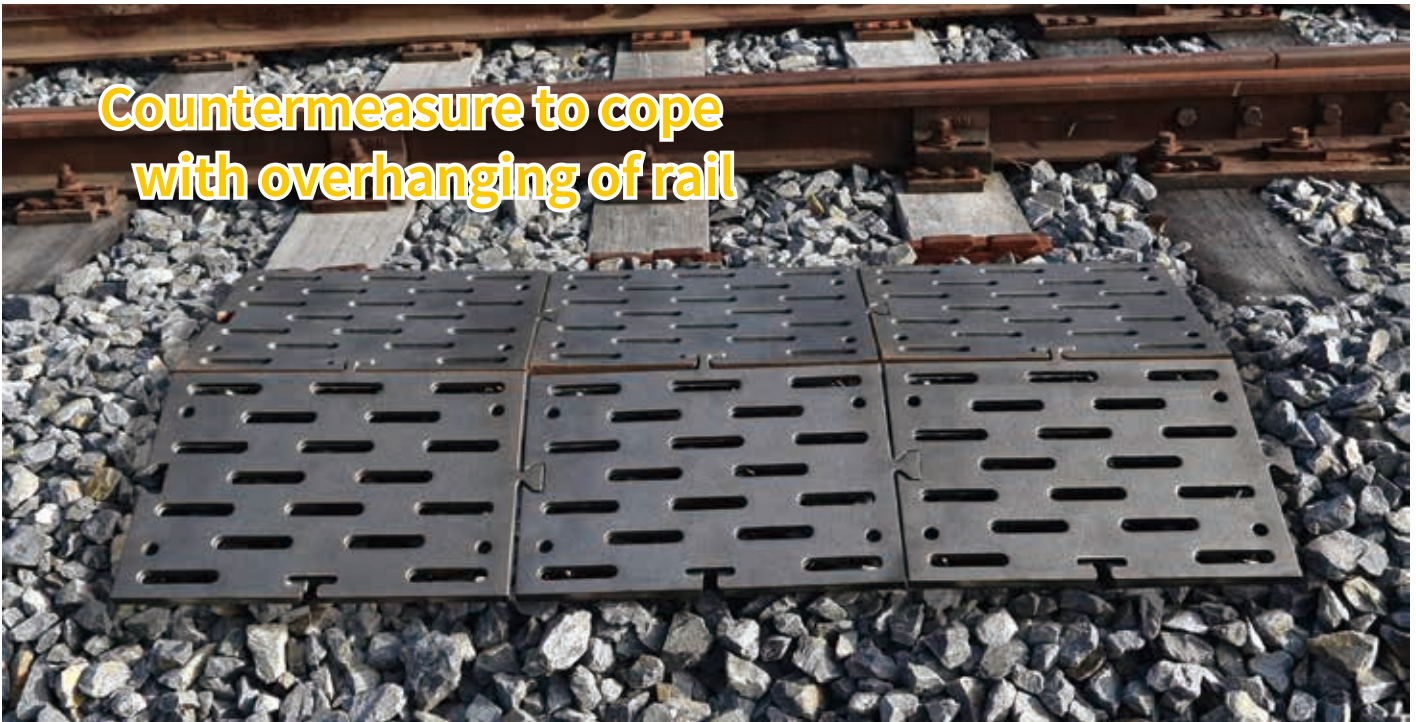
Effective by placing on the ballast
No tools necessary for installation
Free extensions are possible in length/width

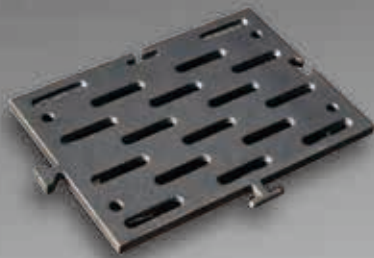
Plate surface

The plates have slit for drainage & air vent. Possibility of scattering by strong wind are limited due to the slit.

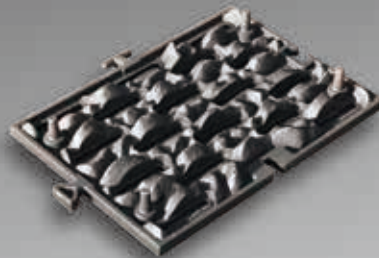
Back-side of the plate

The crushed stone shape back-side makes good contact with the ballast and enhance the stability of the ballast.

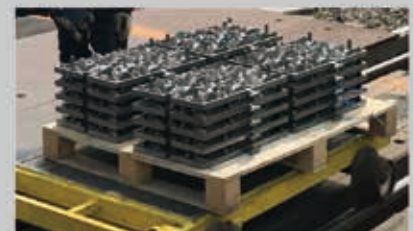
Up & down
connection

The plates can be connected by putting on the fitting without any tools.

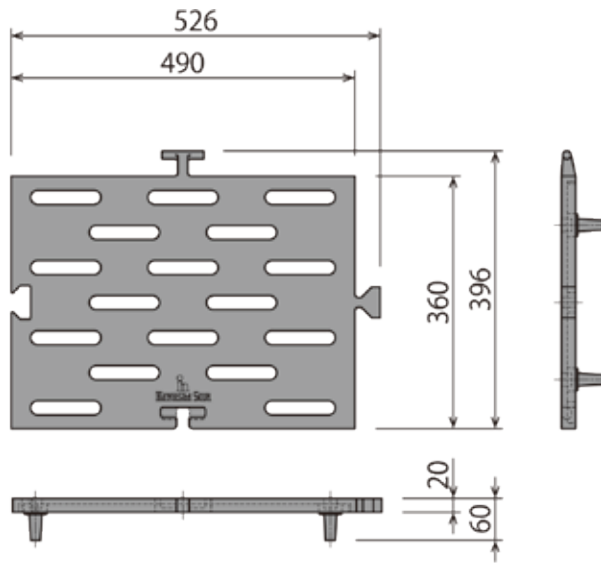
■ Plate dimensions (mm)

Plate dimensions
W526 x D396 x H60 (mm)
 Weight
22kg

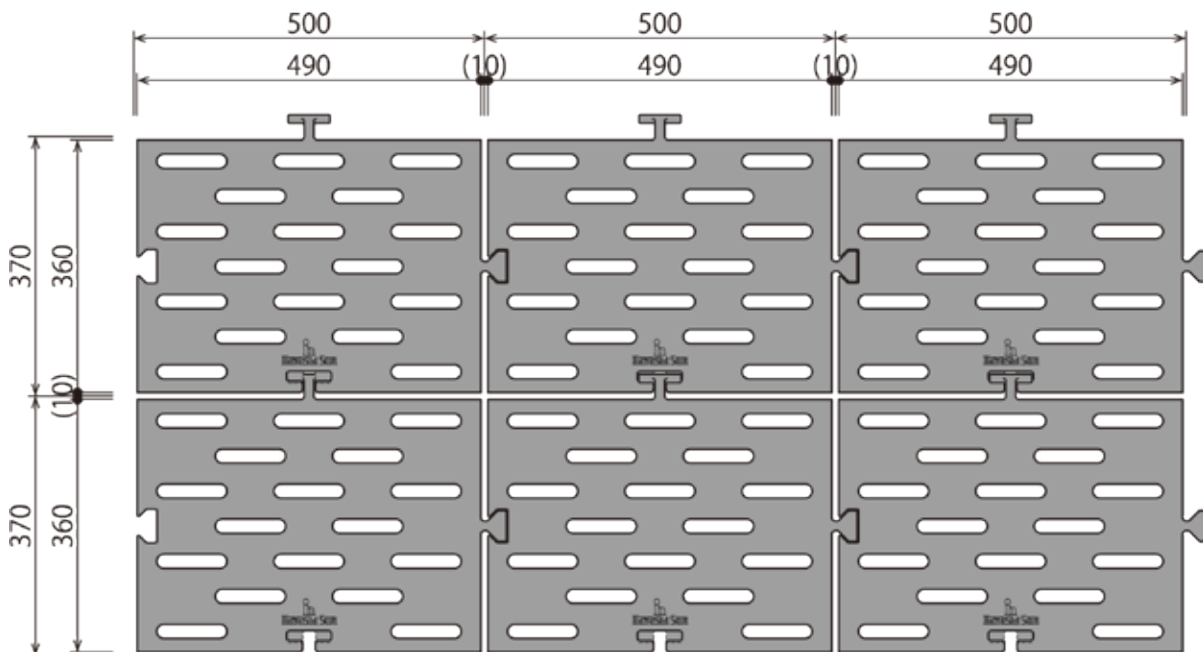
■ Plates layout dimensions, Reference figure (mm)

- The Plates can be connected with the pitch of 500mm cross direction/370mm longitudinal direction.
- 10mm clearance between the plates. (In case of installation on the flat surface)
- The longitudinal connection parts are T-shaped for easy adjustment of the angle.

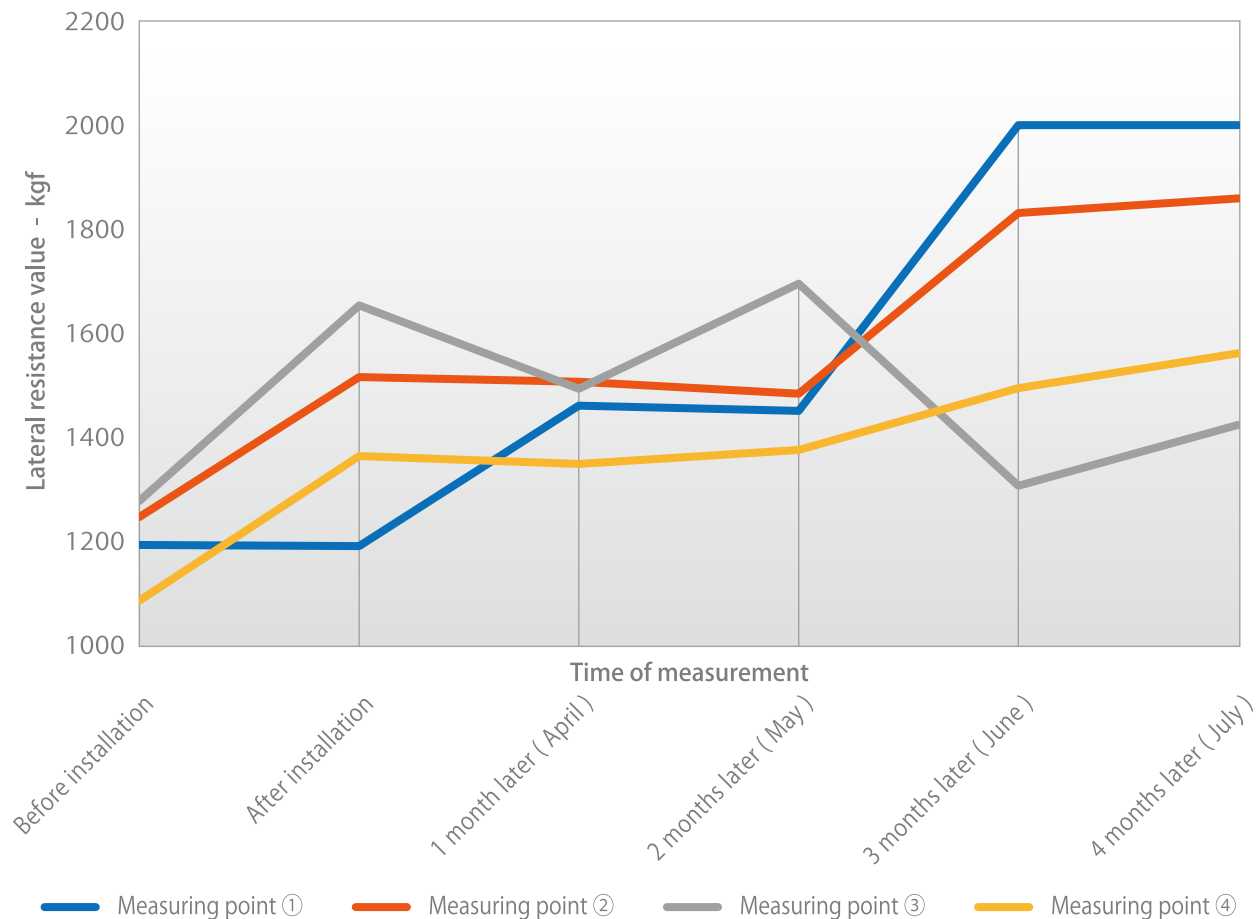
Ballast Holding Plate - Lateral Resistance Value measurement

The results of measurement of lateral resistance value change with the installation of ballast holding plates on the rail track in operation.

The lateral resistance value	Per one sleeper (kgf)			
	Measuring point ①	Measuring point ②	Measuring point ③	Measuring point ④
Date of installation (Mar/2017)				
Before installation	1192	1246	1277	1085
After installation	1190	1515	1653	1363
1 month later (April)	1460	1506	1493	1348
2 months later (May)	1450	1483	1695	1375
3 months later (June)	* 2000	1831	1306	1494
4 months later (July)	* 2000	1859	1423	1561

* Above 2 red lines show that we could not measure the values due to the situation that lateral resistance values passed over 2,000 kgf.

We stopped the measuring on Jul/23 because we found the results are satisfactory after measuring from temperature rising season to intense heat season.
